**TECHNICAL MEMORANDUM**  
**REMEDIAL DESIGN/REMEDIAL ACTION PLANNING SUPPORT**  
**ESCAMBIA WOOD TREATING SUPERFUND SITE, PENSACOLA, FL**

Final Report, 1 June 2021

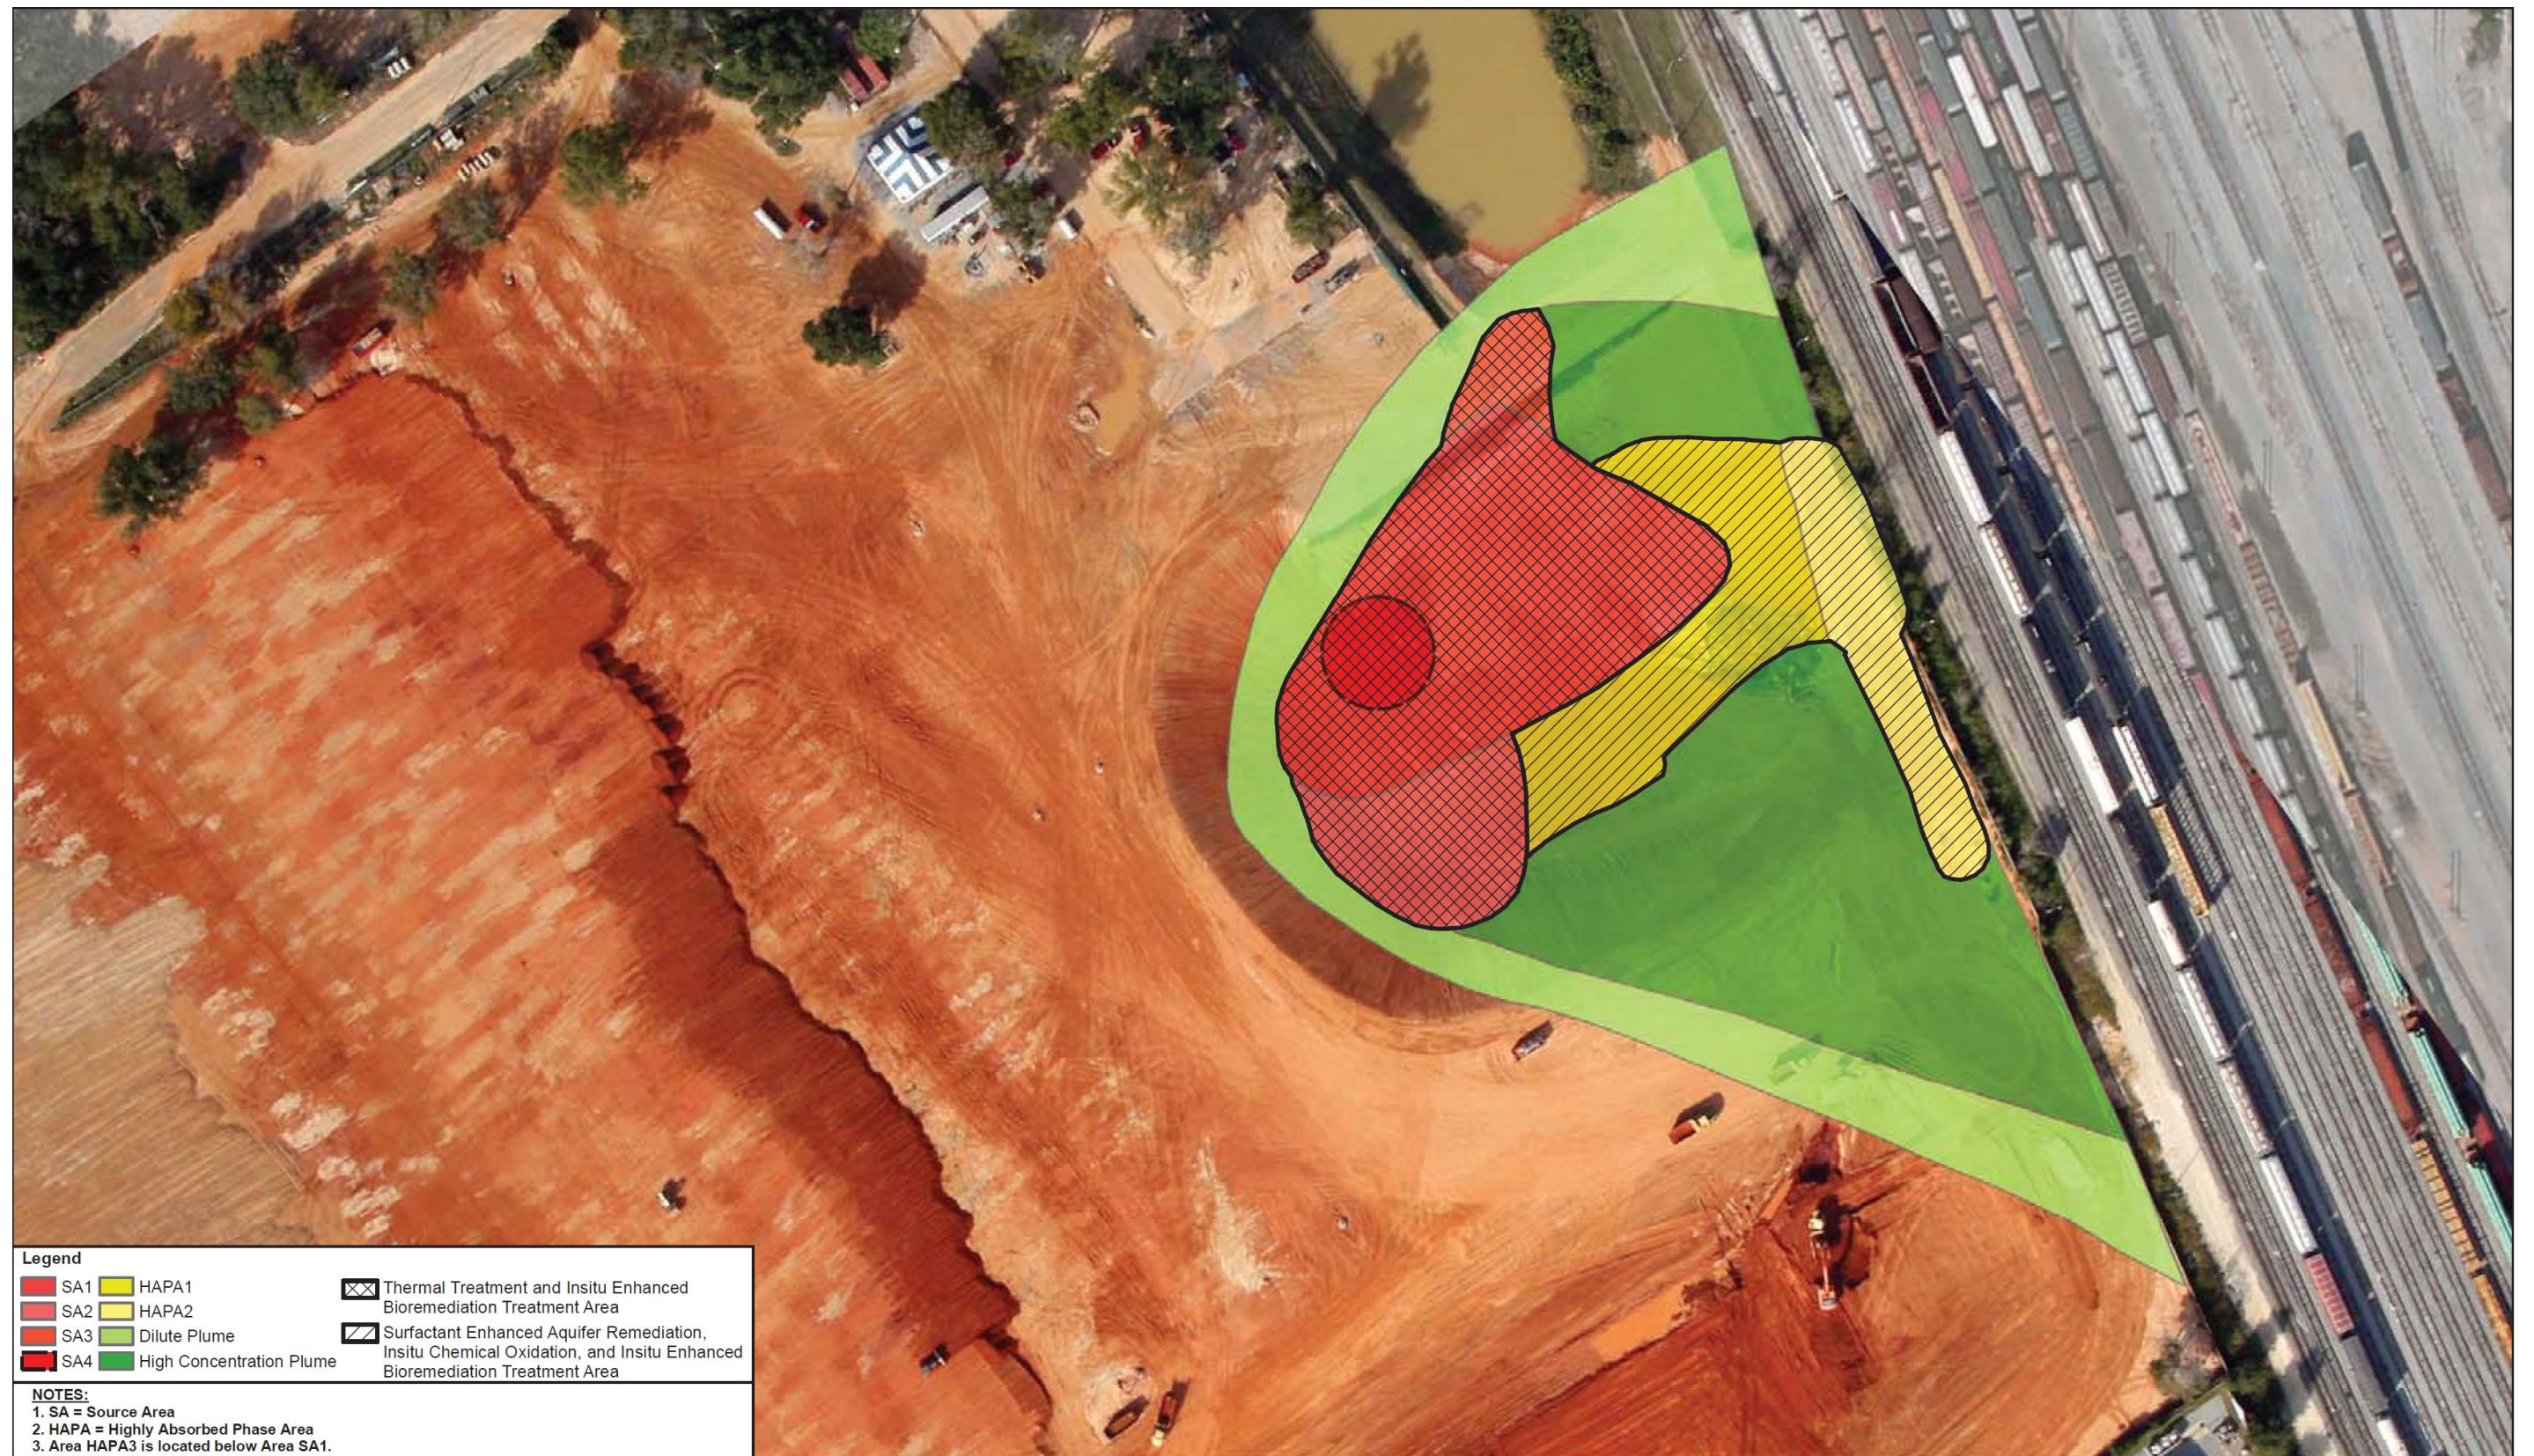
Figure 3 – Contaminated Media Zones (from 2014 Focused Feasibility Study)

The boundaries of these four areas – as they were defined in the Amended Record of Decision (EPA, 2015) are shown on **Figure 3**. The selected remedy identifies a suite of remediation technologies which may be applied individually or in combination depending on the physical location and remedy implementation phase: steam-enhanced extraction (SEE) (note that the AROD provides for consideration of other approaches to thermal enhancement), in-situ enhanced biodegradation (ISEB), surfactant-enhanced aquifer remediation (SEAR), and in-situ chemical oxidation (ISCO). The Final Remedial Design Document (Versar, 2016) defines four phases for remedy implementation:

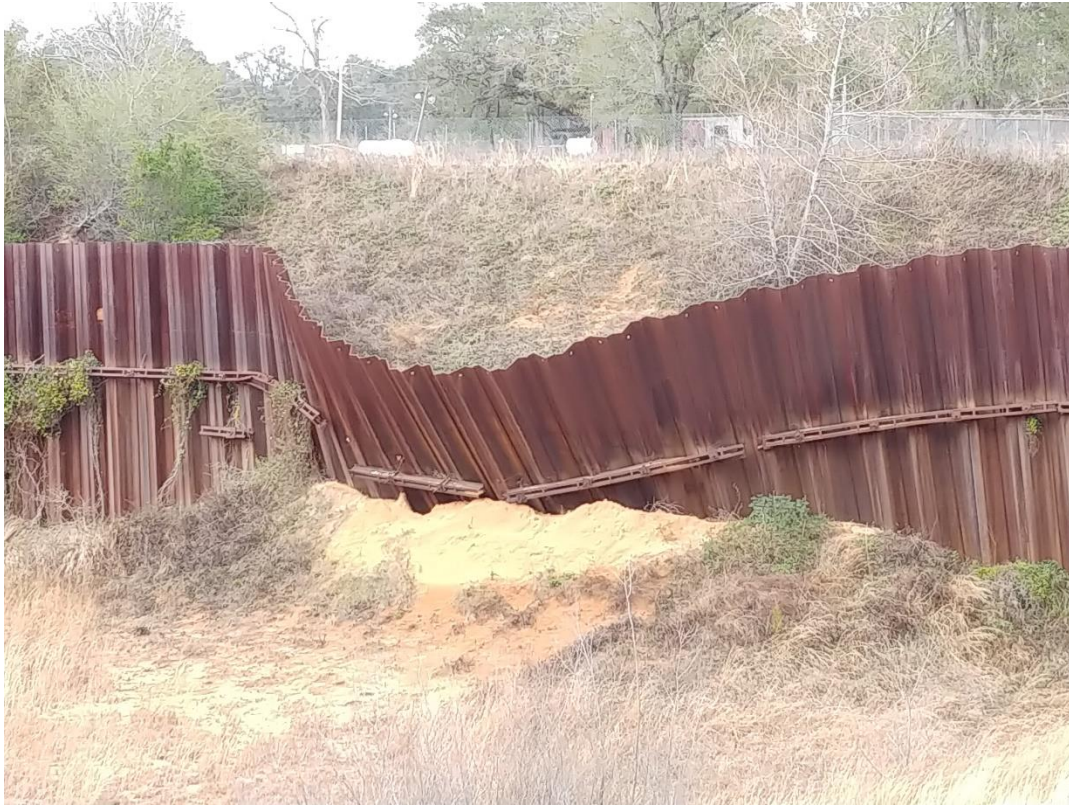
SWMU 10 sheet piling bulge

- A significant flooding event occurred at SWMU 10 in 2014; although not an enforcement/remedial activity, this event warrants some discussion here. In April 2014, the ETC site and surrounding area received nearly two feet of rain in roughly one day. This caused the stormwater impoundment located immediately to the north of SWMU 10 to overtop and breach. The overtop/breach directed stormwater and sediment into SWMU 10 and also damaged the sheet-pile retaining wall located on the north side of the SWMU 10 excavation. Water remained ponded in the excavation for an extended time. The eroded embankment of the stormwater impoundment was repaired in 2015; the damage to the SWMU 10 sheet pile wall was not able to be repaired, and the sheet pile wall remains erect but bowed inward.

Currently, the fringes of the SA and HAPA intersect the side slopes of the SWMU 10 excavation; furthermore, a portion of the SA overlaps the bowed-in portion of the SWMU 10 sheet pile wall. Both of these conditions will likely create challenges to installing wells for remediation. To provide access along the current side slopes of SWMU 10, the excavation could be benched instead of using linear slopes. The bowed portion of the SWMU 10 sheet pile wall (~120 linear feet of sheet pile) will likely need to be removed to allow access for drilling equipment. The other portions of the sheet pile wall may not need to be removed; given that the sheet pile wall doesn't extend very far into the water table, it's unlikely that the wall would significantly impact the Phase 1 and Phase 2 remedy as long as access for well installation isn't an issue.

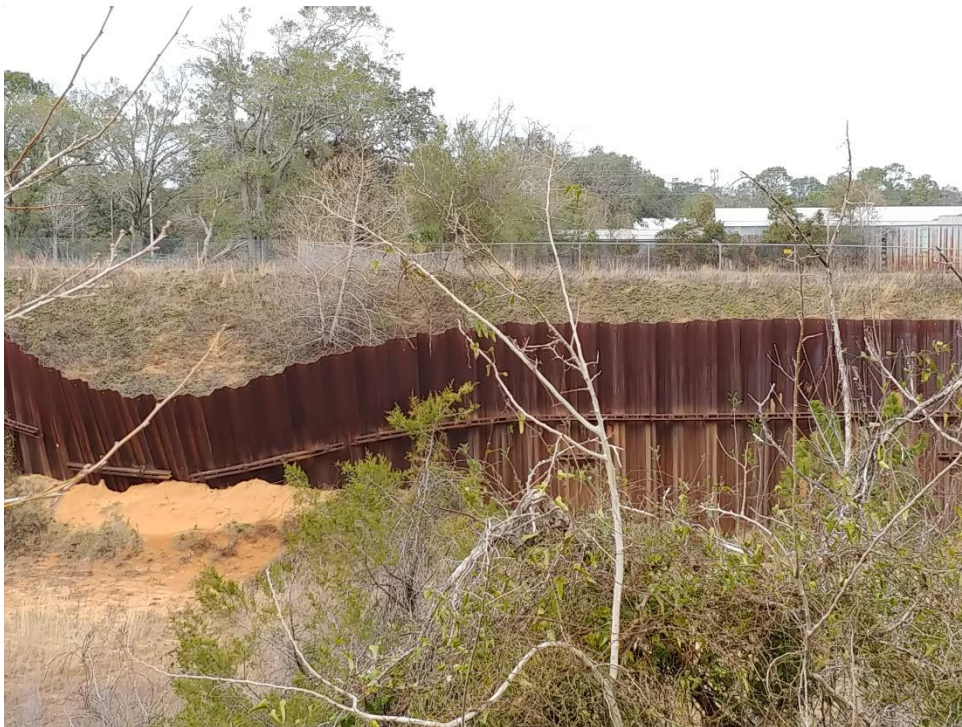
Another view of the sheet piling bulge

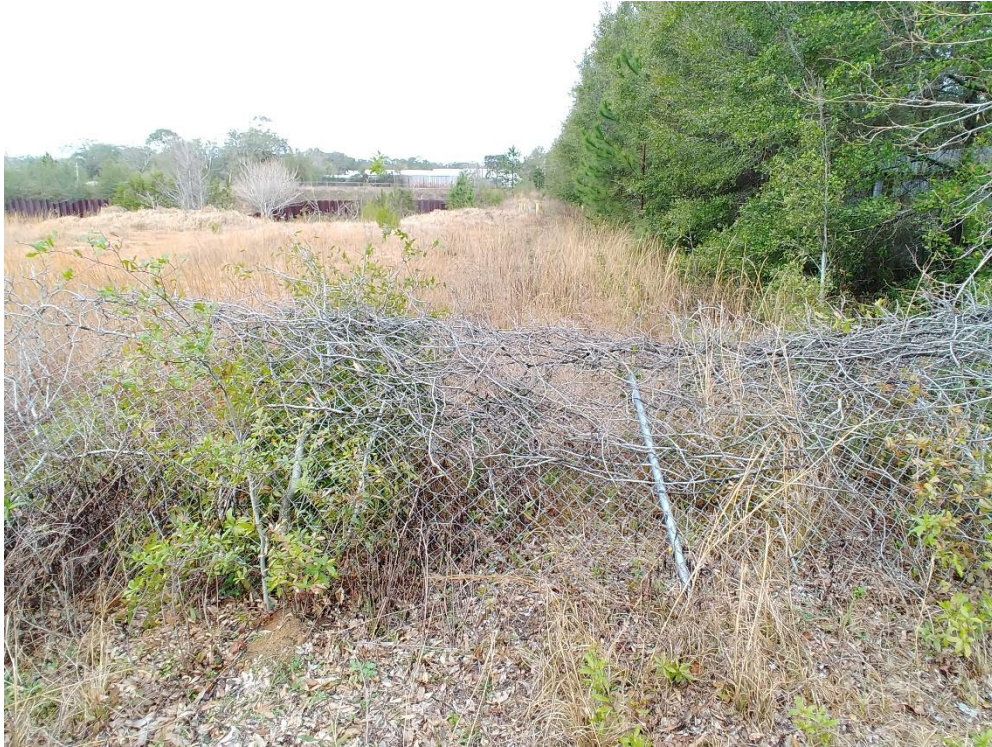
Fence bent southeast part of SWMU 10
